Case 249 : Narrative

Case Vehicle (A): 1999 Jeep	Veh. (B): 1998 Ford
Type: Grand Cherokee Laredo, 4 x 4, 4-door SUV	Type: Escort Sport SE, 4-door sedan
Driver: 50- year-old male	Driver: 33- year-old female
CDC: 12-FYEW-2	CDC: 01-FDEW-2

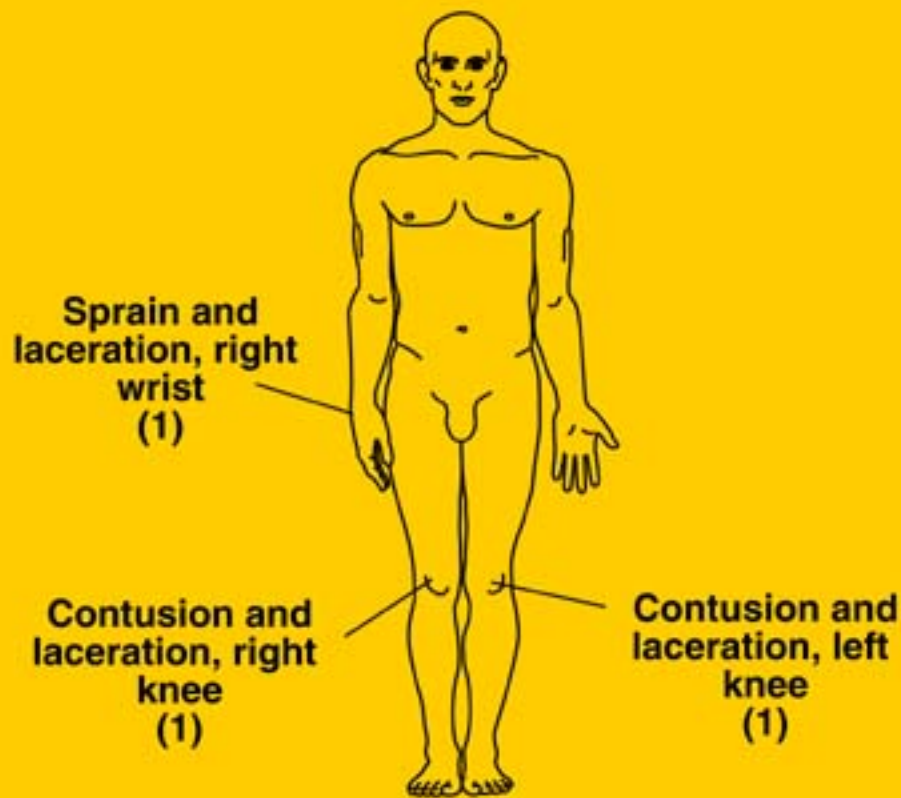
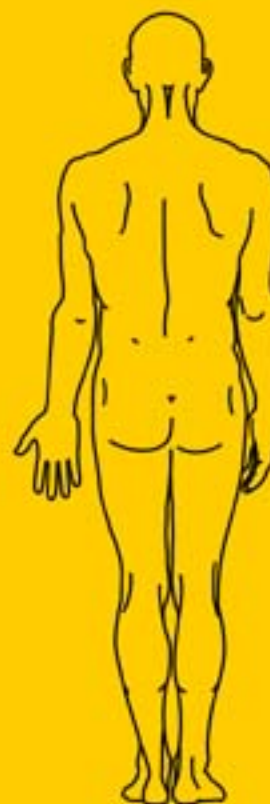
Occupant: Driver	Age: 50 years	Gender: Male		
Restraints: 3-point belt worn; frontal-impact airbag deployed	Stature: 168 cm (5 ft, 6 in)	Mass: 84 kg (185 lb)		
Injury Description	A.I.S.	Injury Source		
—	—	Definite	Probable	Possible
Sprain, right wrist	1	—	—	Airbag
Laceration, right wrist	1	—	—	Airbag
Contusion and laceration, right knee	1	—	Knee bolster	—
Contusion and laceration, left knee	1	—	Steering column	—
Maximum A.I.S. Level	1	—	—	—
Injury Severity Score	2	—	—	—

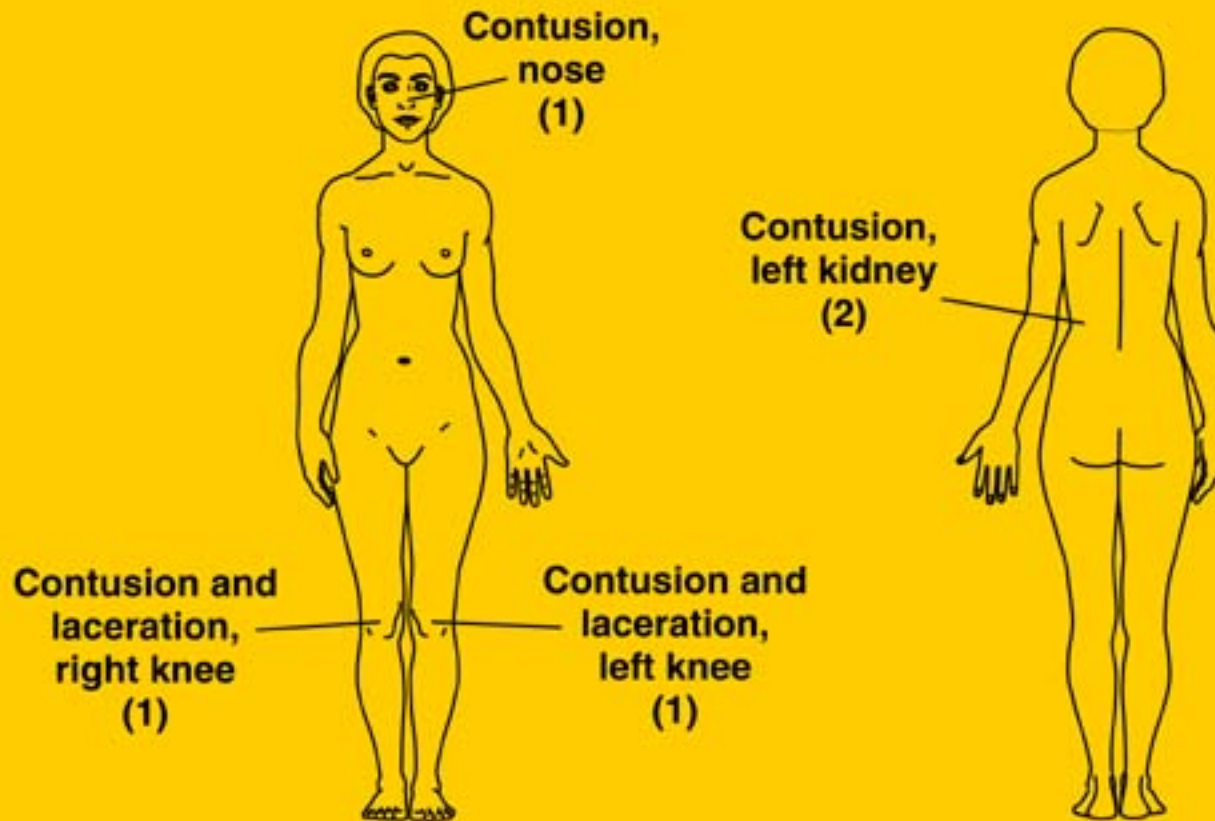
Occupant: Right front	Age: 44 years	Gender: Female		
Restraints: 3-point belt worn; frontal-impact airbag deployed	Stature: 165 cm (5 ft, 5 in)	Mass: 75 kg (165 lb)		
Injury Description	A.I.S.	Injury Source		
—	—	Definite	Probable	Possible
Contusion, nose	1	—	Airbag	—
Contusion, left kidney	2	—	Center armrest/console	Seatbelt
Contusion and laceration, left knee	1	—	Glove box door	—
Contusion and laceration, right knee	1	—	Glove box door	—
Maximum A.I.S. Level	2	—	—	—
Injury Severity Score	5	—	—	—

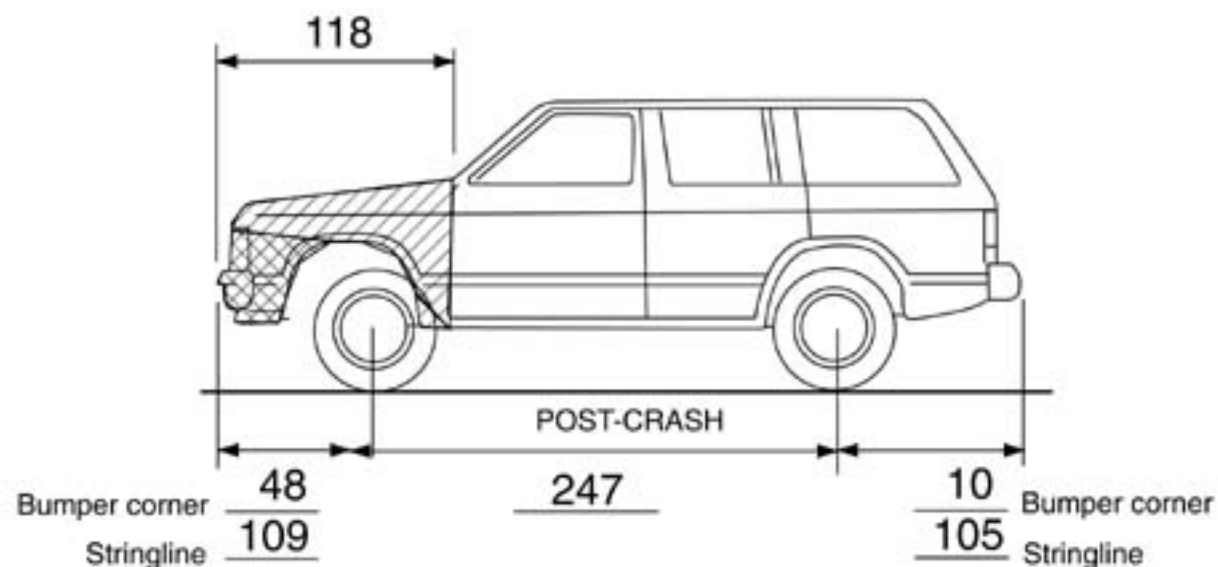
Max. crush to left front bumper corner

[8](#) Damage to case vehicle (A) was moderate. Direct contact damage began at the left-front bumper corner and extended 80 cm to the right, resulting in 50-percent vehicle overlap. [9](#) The maximum crush was 38 cm to the left-front bumper corner.

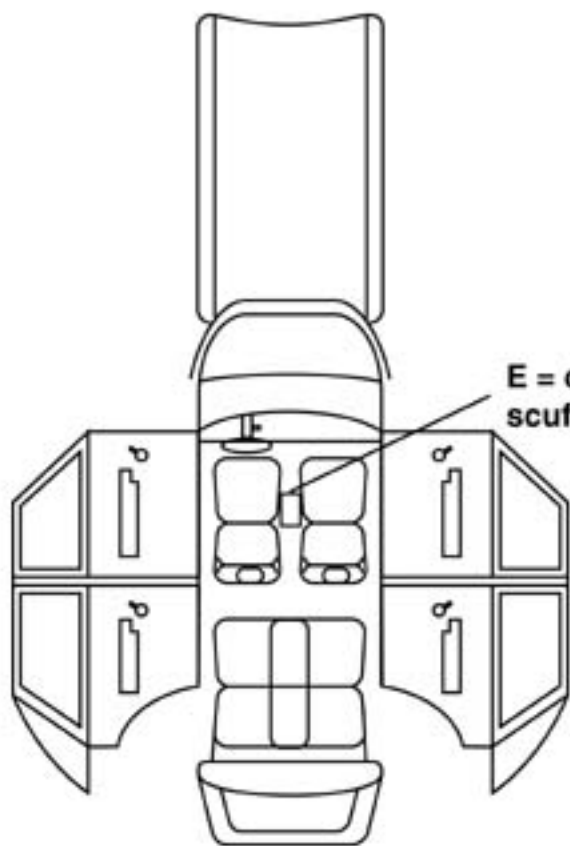
Contact	Interior Component Contacted	Occupant No. if Known	Body Region if Known	Supporting Physical Evidence	Confidence Level of Contact Point
A	Steering column	DR	Lt. knee	Scuffed	1
B	Knee bolster left of vertical console	DR	Rt. knee	Scuffed	1
C	Knee bolster/glove box door	RF	Lt. knee	Scuffed	1
D	Knee bolster/glove box door	RF	Rt. knee	Scuffed	1
E	Center armrest	RF	Lt. hip	Scuffed	1
F					
G					
H

**E = center armrest/console,
scuffmark**
